INTERNATIONAL FIRE PROFESSIONAL

Victoria Street Building Collapse – Fire and rescue when the unimaginable happens

It is just over a year since the town of George in South Africa's Western Cape was rocked by a devastating tragedy when a multi-storey apartment block under construction collapsed. Santa Sternsdorf, Station Commander from the George Fire and Rescue Department, summarises the incident and the rescue operation.

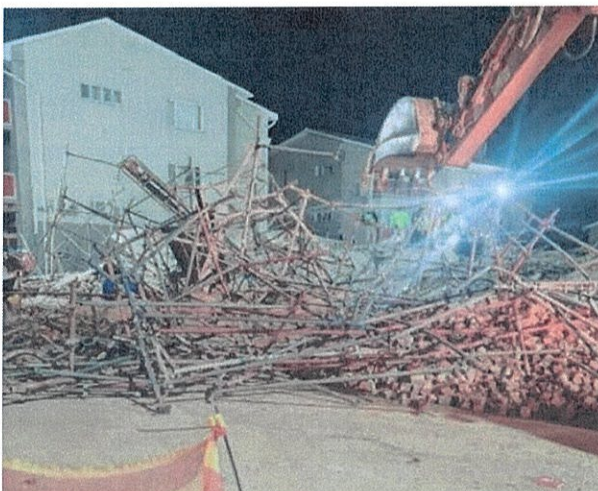
Scaffolding on site posing risk to rescue workers

Initial challenges on the scene included determining the location of live victims and determining which types of resources were required to rescue them. Scaffolding was hanging precariously over the front (north) and western side of the collapsed building, which was considered dangerous.

- ◆ Securing access points, first with rebar and later using wooden T-Spot shores. Confined space search operations
- ◆ Removal of destroyed scaffolding and moving all debris off-site.

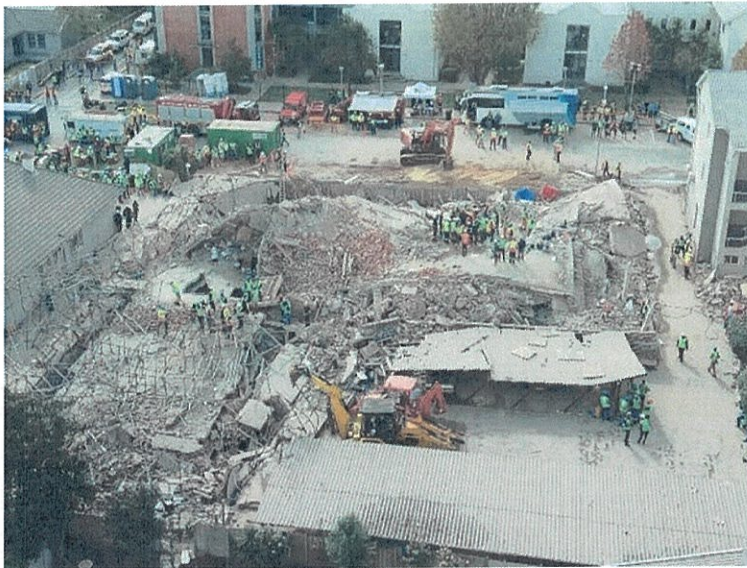
There were two asbestos-roofed parking structures, at the back of the collapsed building's property, being used by occupants of the neighbouring apartments. A section of the asbestos roof had been damaged in the collapse and immediately raised hazardous material concerns.

The asbestos roof of the parking structure was damaged during the collapse, creating a potential health and safety risk to everyone on site. Incident commander, Fire Chief Neels Barnard, arranged for an accredited service provider to remove all asbestos from Delta Sector before work could recommence.

Damaged Asbestos roof in Delta Sector

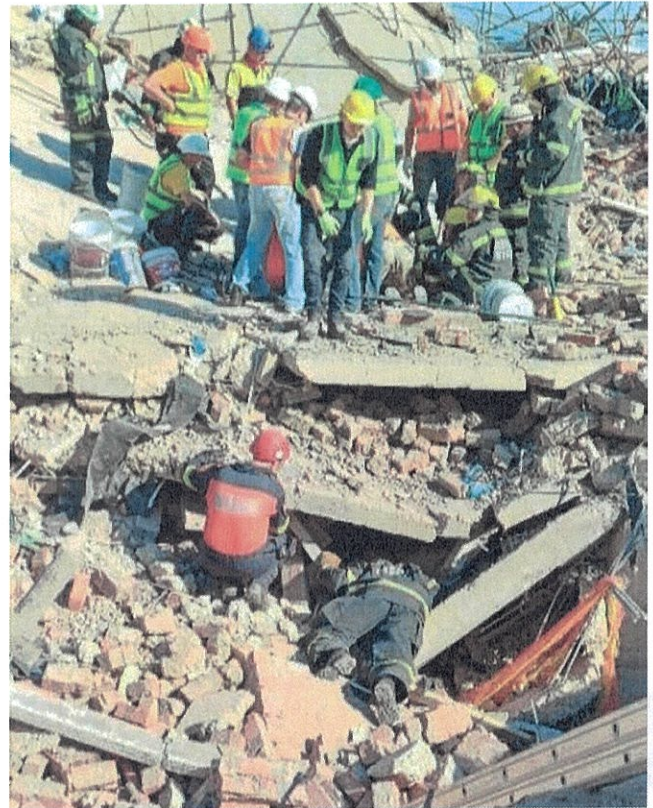
Rescue operations prioritizing live victims

Operations were complicated by the poor quality of building materials which did not behave in the manner rescue workers were accustomed, such as concrete that would turn into powder instead of breaking into manageable pieces, causing concrete slabs to unexpectedly shift. These factors were of great concern to the safety of emergency personnel.

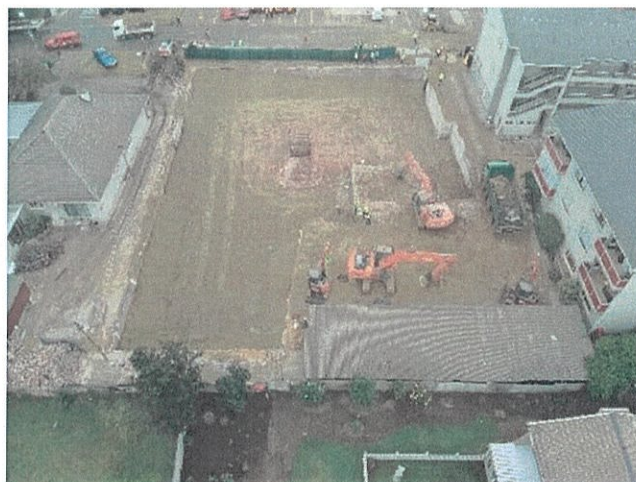
Site cleared before handing over to SAPS
